UH-1N INSTRUMENT FLIGHT, TURBULENCE, AND ICING TESTS

TECHNICAL REPORT No. 71-9

MARCH 1971

**AIR FORCE FLIGHT TEST CENTER
EDWARDS AIR FORCE BASE, CALIFORNIA
AIR FORCE SYSTEMS COMMAND
UNITED STATES AIR FORCE**

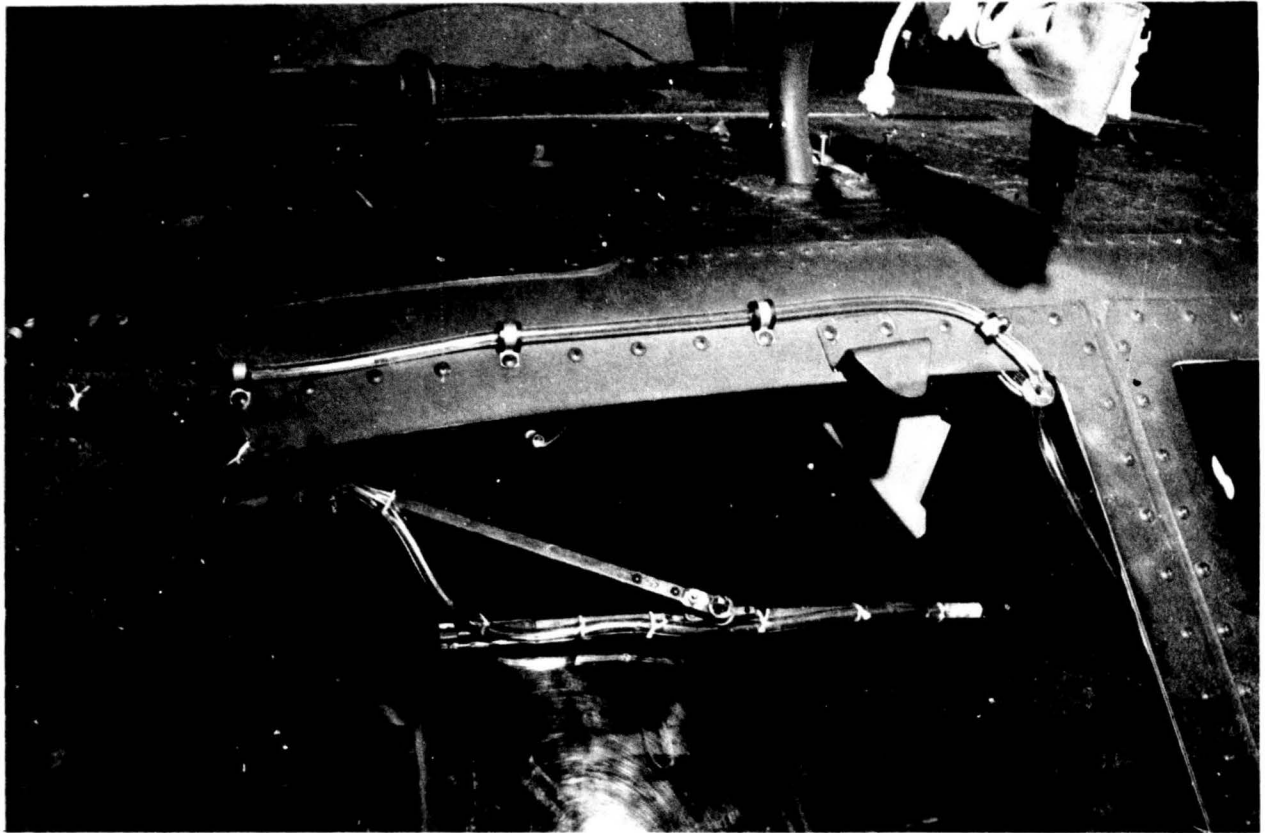
Figure 3 Class II Modification – Plastic Hose Attached to Wiper

The UH-1N windshield defrosting system was inadequate for ice removal as shown by results of the UH-1F icing test program (reference 7). Consequently, a de-icing system was installed to give the pilot visibility during icing tests. The system consisted of a 2-gallon tank (containing alcohol), an electric pump and flexible plastic hose (figures 2 and 3). The de-icing system received power from the aircraft 28-volt dc essential bus. When the system was activated, alcohol was pumped through plastic hose to the windshield wiper and onto the windshield.

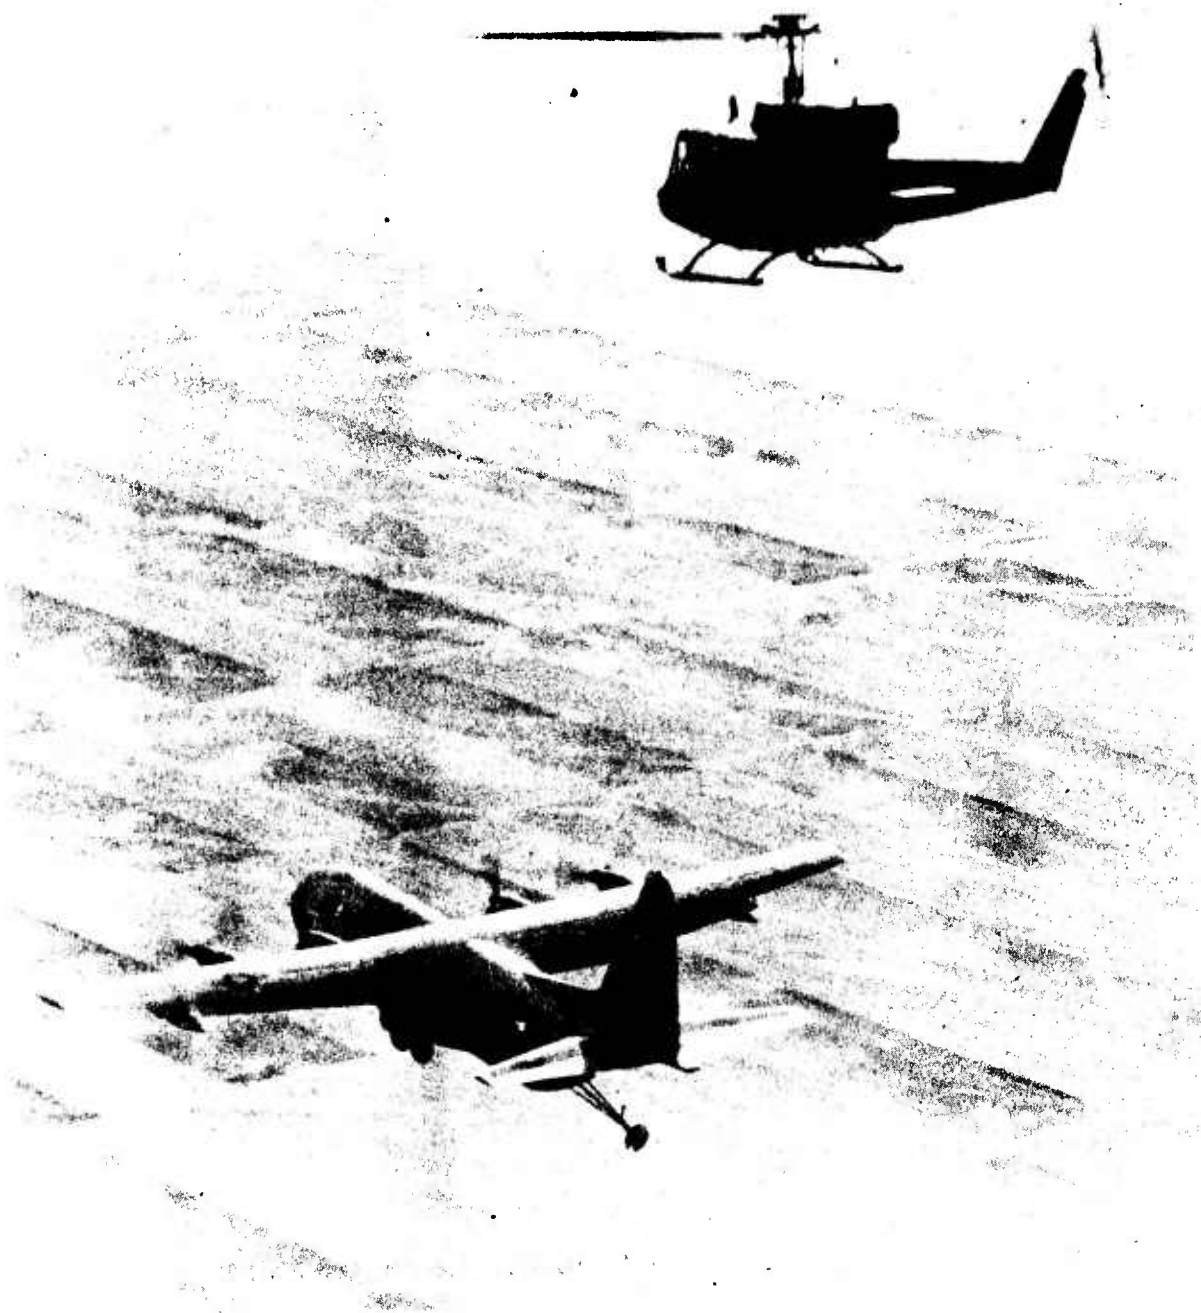
Figure 4 Rendezvous of C-130 Water Spray Aircraft and UH-1N

The UH-1N test helicopter, the chase helicopter (UH-1F), and C-130 spray tanker rendezvoused over a predetermined area 18 miles north of MAFB, Montana (figure 4). Testing was conducted between 5,500 feet and 9,500 feet pressure altitude with freezing temperatures at the surface. Trace, light, and moderate conditions of clear and rime icing were evaluated (appendix III). The UH-1N was iced enroute to MAFB, over barren, sparsely populated terrain. After being iced, the UH-1N landed at MAFB to have photographs taken, ice accretion evaluated, and ice removed. Table IV lists test points. The test helicopter then rendezvoused with the C-130 to continue testing. For all test points, the UH-1N weighed approximately 8,200 pounds.
